(Boot Replacement)

(CV JOINT CLEANING / REPLACEMENT)

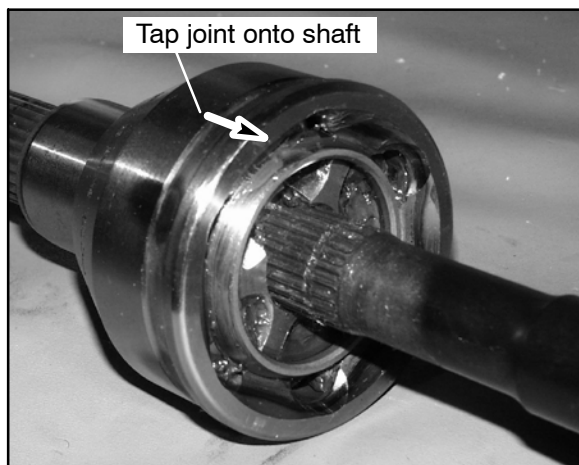
5. Refit CV joint on interconnecting shaft by tapping with a plastic hammer on the joint housing. Take care not to damage threads on the outboard CV joint. The joint is fully assembled when the snap ring is located in the groove on the interconnecting shaft.

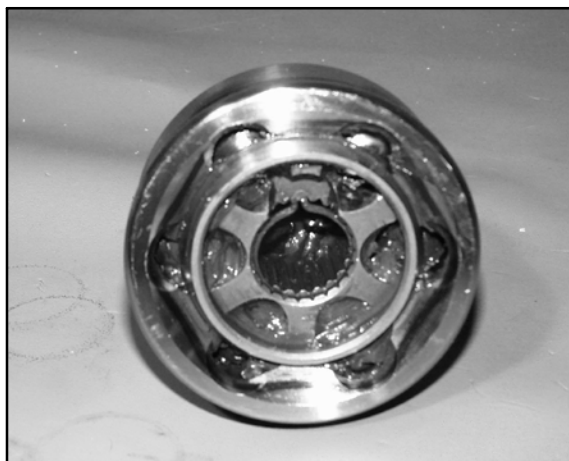
3. Thoroughly clean and dry the CV joint and inspect ball tracks and cages for wear, cracks or other damage.

NOTE: Shiny areas in ball tracks and on the cage spheres are normal. Do not replace CV joints because parts have polished surfaces. Replace CV joint only if components are cracked, broken, worn or otherwise unserviceable.
